WHITE PAPER: STAINLESS STEEL THREAD GALLING

HOLD THE CABLES. HUG THE RUNG.[®]

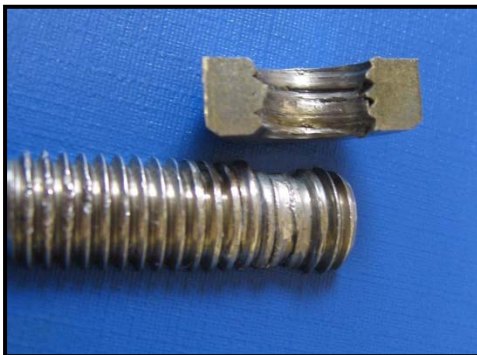
Figure 1 – Thread Galling Example

Details: Although it affects aluminum and titanium, in the electrical industry, galling is most often encountered when installing threaded stainless steel fasteners. Stainless steels are characterized by a naturally-occurring surface oxide layer that protects the metal substrate. During fastener tightening, frictional heating occurs on the surfaces of the mating threads. If the friction is excessive, the protective oxides can break down, filling the threads with metal particles and exposing the unprotected threaded metal surfaces to one another. While galling initially results in binding. In extreme cases, galling can result in complete thread seizure. Changing installation technique(s) has proven to be the most effective solution for thread galling.
